FLIR thermal imaging camera helps find water leakage at Italian swimming pool

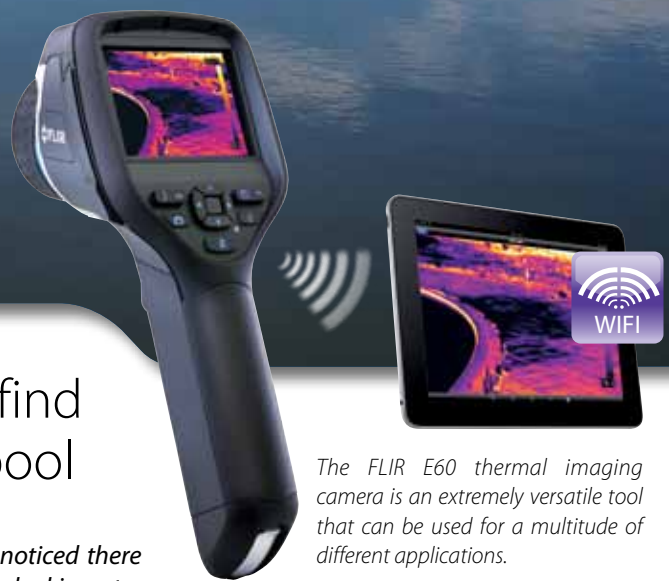
The FLIR E60 thermal imaging camera is an extremely versatile tool that can be used for a multitude of different applications.

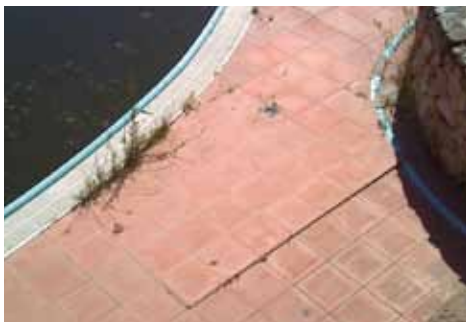
An initial survey did not show enough decisive signs of leakage, so Contino took it one step further. He plugged the nozzle of the pool cleaning system, thus pressurizing the water in the pipes. “The pavement was warmed up by the sun, so at the location of the leakage we suspected that the water leakage would cool down the pavement. So after waiting for two hours we performed a second survey and looked at the differences between the two. And just like we thought there were two suspicious areas in the second survey that appeared cooler in the thermal images. So you could say we used the sun as an infrared illuminator.”

Visual and thermal image of one of the two suspected areas.

Contino directed the repair workers to the two sites so they could open up the pavement in the suspected areas and dig

up the pipes. "This showed that some of the pipework in those locations was cracked or broken. This validated the findings in the thermographic survey, showing very clearly that this method had led to an accurate localization of the problems."

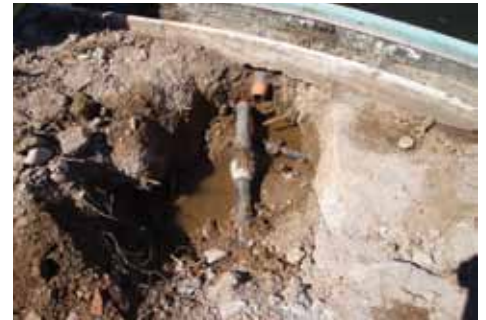
The repair workers were directed to open up the pavement where leaks were inspected, to find broken or cracked pipework, validating the results from the thermographic survey.
