FLIR Systems assists NASA in improving safety in space

The NASA Langley Research Center has chosen the FLIR Systems ThermaCAM™ S65 as the preferred infrared camera system for its current shuttle and International Space Station programs

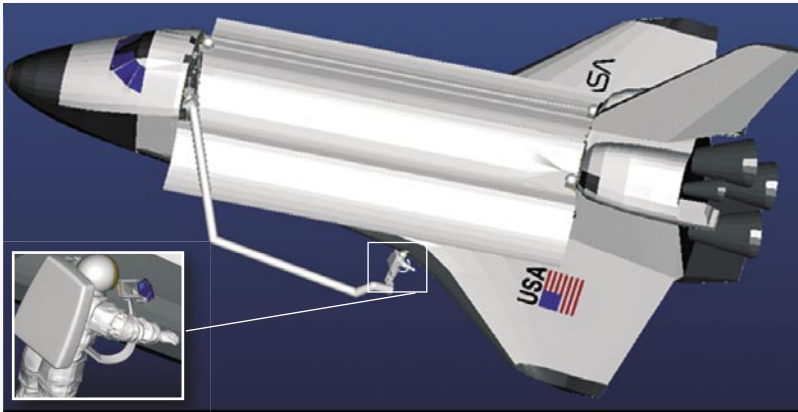
During a spacewalk an astronaut searches with the ThermoCAM S65 for damages at the wing-leading edge.

The shuttle is orbiting around the earth. During the time that it is flying over the part of the earth where it is daylight, it is heated by the sun. Once it flies into the shadow of the earth, the shuttle starts to cool off. At this point in time, during a space walk, an astronaut is looking with the infrared camera at the wing-leading edge. An infrared sequence is stored in the camera.

Once back in the shuttle, this sequence is downlinked to earth where image processing can decide if cracks or laminations are present. Smaller cracks and delaminations, which can be extremely dange-

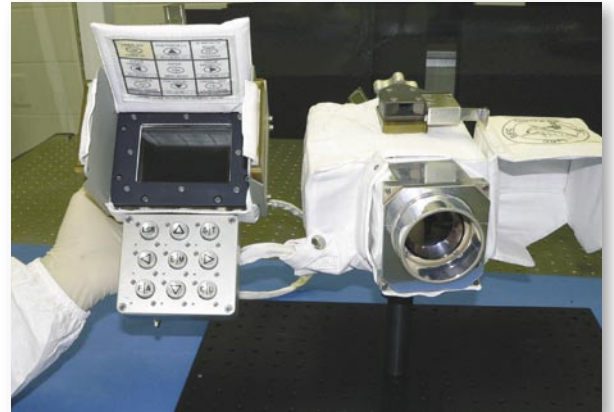
The protective housing for the ThermoCAM S65 as developed by NASA

In January 2005, a joint cooperation project was set up to adapt the camera to the stringent Shuttle Program space-flight requirements. These modifications would enable the camera to withstand cosmic and intense sun radiation, fire hazards, shocks, vibration and severe temperatures. Moreover, the crew had to be provided with a camera it could operate wearing big gloves during space-walk inspection rounds.
