## FLIR T335 equipped with MeterLink speeds up thermal inspections at FIAT factory

*At the FIAT factory in Melfi, Italy, where several different FIAT models are being produced, inspections with FLIR thermal imaging cameras play an important part in the predictive maintenance program. The information obtained during the thermal imaging surveys are used to predict electrical and mechanical faults so they can be fixed before they become production halting breakdowns.*

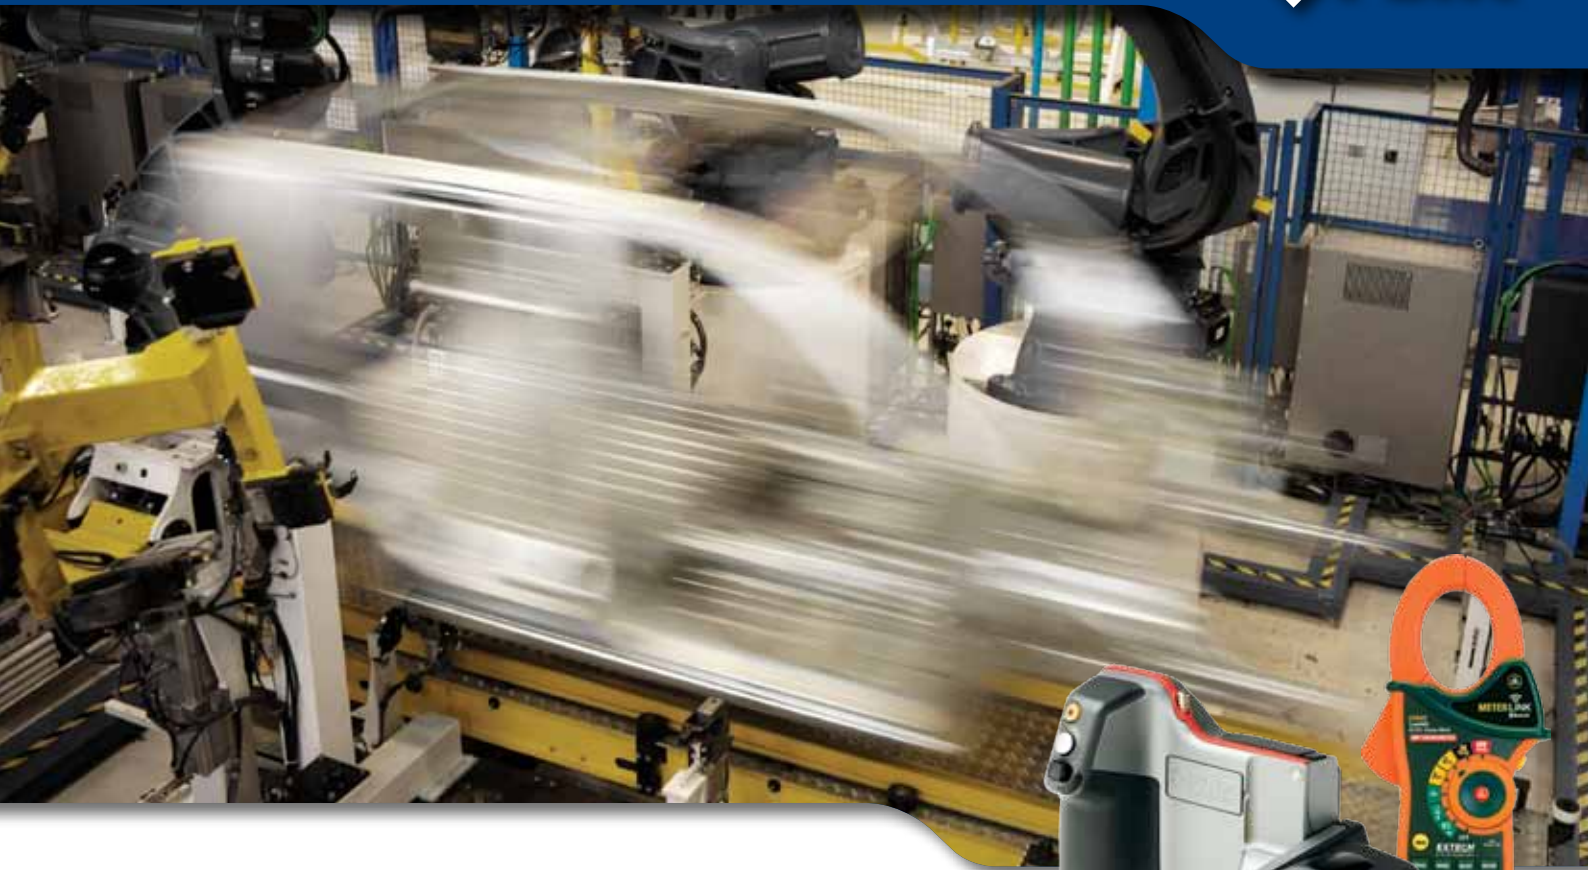
FLIR T335 thermal imaging camera with Extech EX845 clamp meter

Recently Alliata has been able to add even greater value to his thermographic inspections at FIAT Melfi with FLIR's Meterlink connectivity solution. It consists of a Bluetooth connection between the FLIR thermal imaging camera and an Extech EX845 clamp meter. The measurement data is automatically embedded in the corresponding radiometric thermal image. This new functionality greatly improves the accuracy and speed of the thermal imaging inspections, according to Alliata.

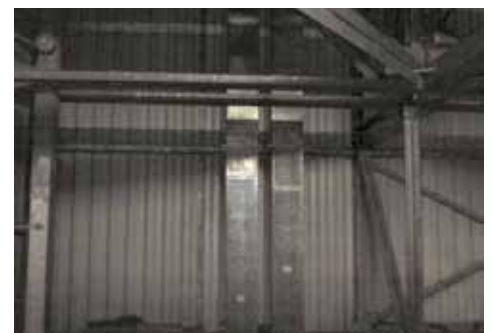
This thermal image shows an imbalance between the conductive strips.

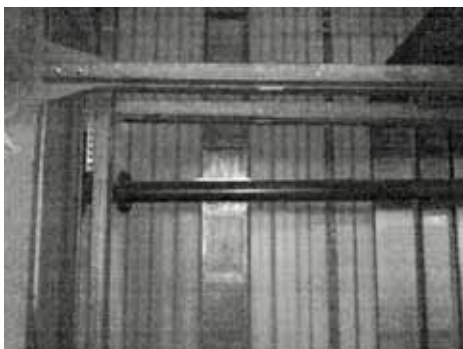
*This thermal image shows an imbalance between the two bundles of cut lengths of busway.*

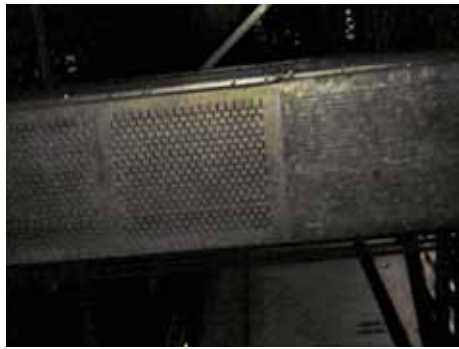
*The thermal image shows that the average temperature difference between the two groups of strips is about 5 °C, with a peak of over 15 °C.*

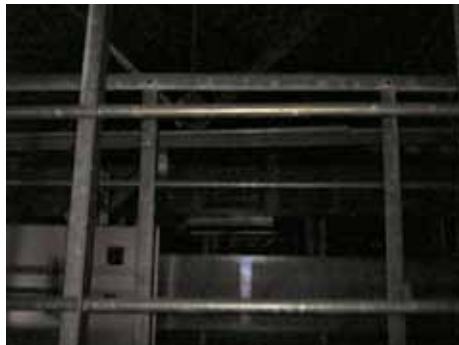
*This thermal image shows a significant increase of temperature on strips of the blind.*
