## Thermal imaging cameras: a fast and reliable tool for testing solar panels.

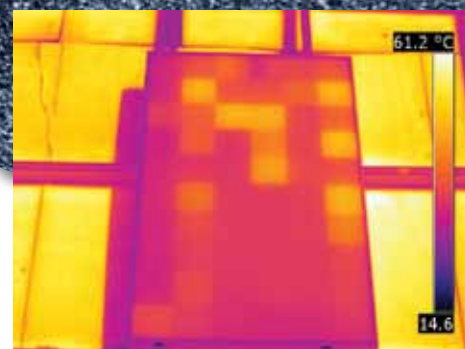
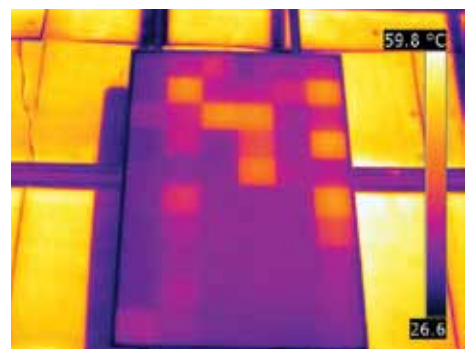
*Thermogram with level and span in automatic mode (above) and in manual mode (below).*

Handheld thermal imaging cameras for predictive maintenance inspections typically have an uncooled microbolometer detector sensitive in the 8–14  $\mu\text{m}$  waveband. However, glass is not transparent in this region. When solar cells are inspected from the front, a thermal imaging camera sees the heat distribution on the glass surface but only indirectly the heat distribution in the underlying cells. Therefore, the temperature differences that can be measured and seen on the solar panel's glass surface are small. In order for these differences to be visible, the thermal imaging camera used for these inspections needs a thermal sensitivity  $\leq 0.08\text{K}$ . To clearly visualize small temperature differences in the thermal image, the camera should also allow manual adjustment of the level and span.

Photovoltaic modules are generally mounted on highly reflective aluminum framework, which shows up as a cold area on the thermal image, because it reflects the thermal radiation emitted by the sky. In practice that means that the thermal imaging camera will record the framework temperature as being well below  $0^\circ\text{C}$ . Because the thermal imaging camera's histogram equalization automatically adapts to the maximum and minimum measured temperatures, many small thermal anomalies will not immediately be visible. To achieve a high contrast thermal image continuous manual correction of the level and span would be needed.

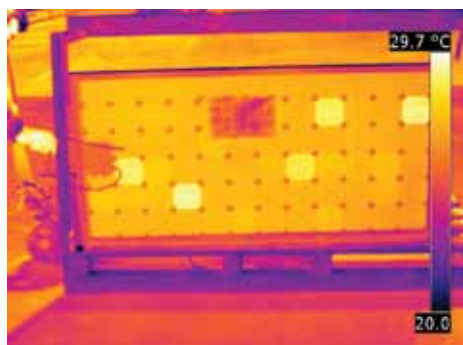
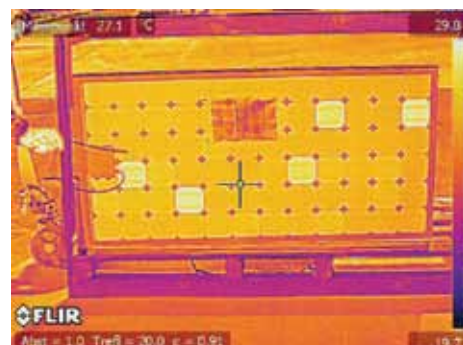
Thermal image without DDE (left) and with DDE (right).

The so-called DDE (Digital Detail Enhancement) functionality provides the solution. DDE automatically optimizes image contrast in high dynamic range scenes, and the thermal image no longer needs to be adjusted manually. A thermal imaging camera that has DDE is therefore well suited for fast and accurate solar panel inspections.

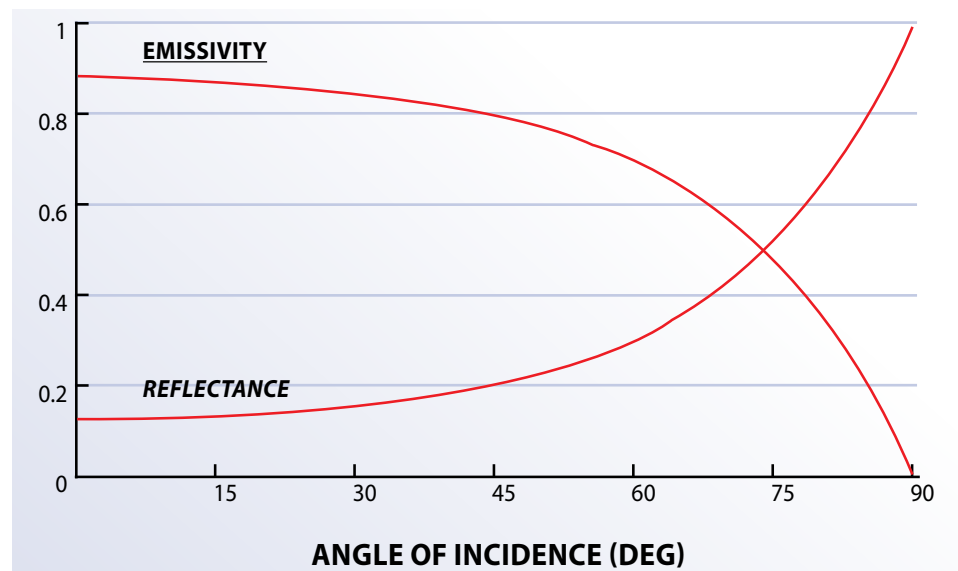
Angle dependence of the emissivity of glass

In order to avoid reflection of the thermal imaging camera and the operator in the glass, it should not be positioned perpendicularly to the module being inspected. However, emissivity is at its highest when the camera is perpendicular, and decreases with an increasing angle. A viewing angle of 5–60° is a good compromise (where 0° is perpendicular).

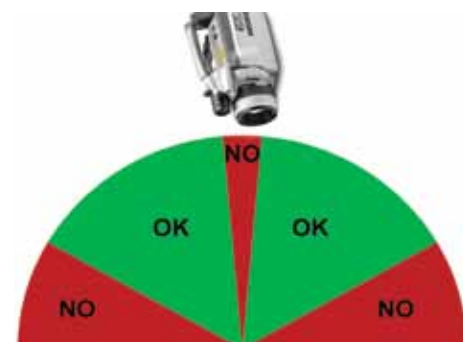
Viewing angle recommended (green) and to be avoided (red) during thermographic inspections.

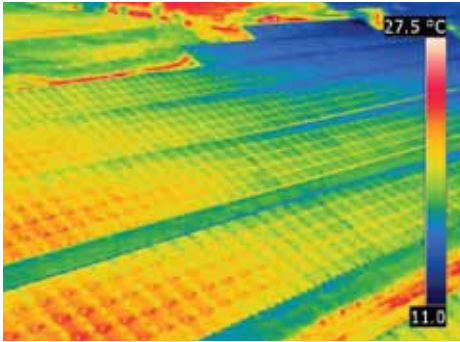
*In order not to draw false conclusions you need to hold the thermal imaging camera under a correct angle when inspecting solar panels.*

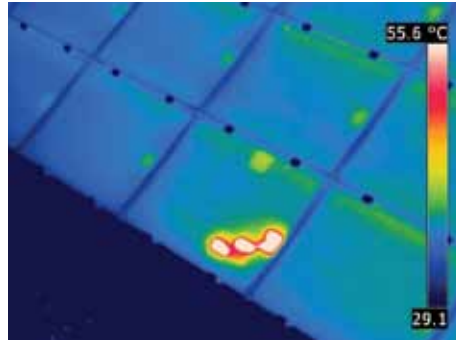
*Thermal image made using a FLIR P660 camera on a flight over a solar farm. (Thermogram courtesy of Evi Müllers, IMM)*

The camera should also have an interchangeable lens, so the operator can switch to a telephoto lens for long distance observations, such as from a helicopter. It is advisable, however, to only use telephoto lenses with thermal imaging cameras that have a high image resolution. Low resolution thermal imaging cameras will be unable to pick up the small thermal details

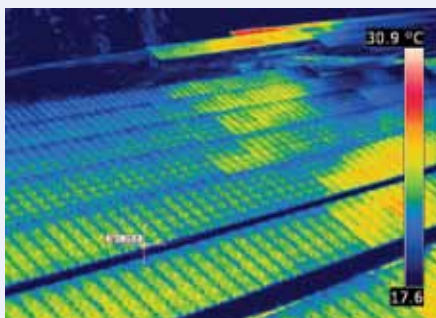
*This thermal image shows large areas with elevated temperatures. Without more information, it is not obvious whether these are thermal anomalies or shadowing/reflections.*

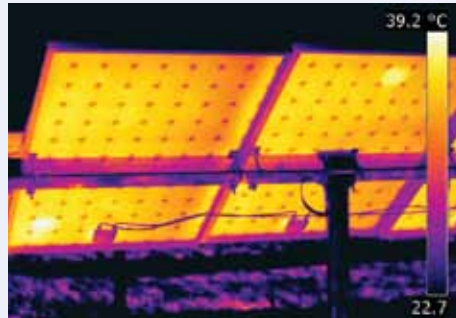
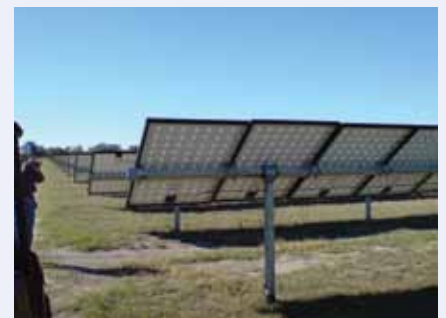
*Thermal image of the back of a solar module taken with a FLIR P660 camera. Its corresponding visual image is shown on the right.*

In most cases installed photovoltaic modules can also be inspected with a thermal imaging camera from the rear of a module. This method minimizes interfering reflections from the sun and the clouds. In addition, the temperatures obtained at the back may be higher, as the cell is being measured directly and not through the glass surface.

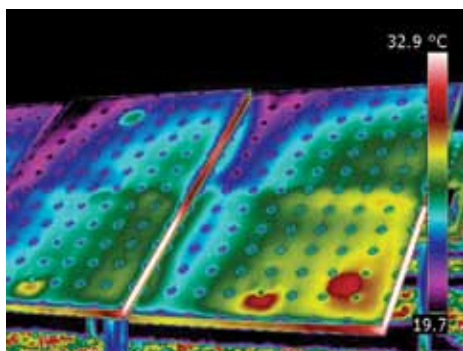
These red spots indicate modules that are consistently hotter than the rest, indicating faulty connections.

and areas can indicate several different faults. If an entire module is warmer than usual that might indicate interconnection problems. If individual cells or strings of cells are showing up as a hot spot or a

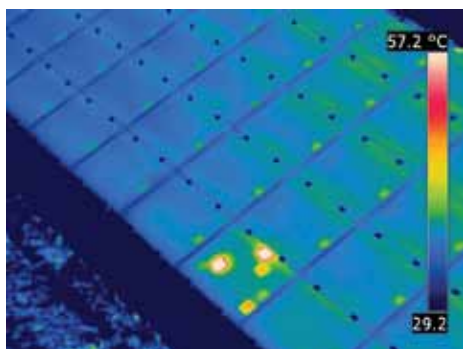
This thermal image shows an example of the so-called 'patchwork pattern', which indicates that this panel has a defective bypass diode.

warmer 'patchwork pattern', the cause can usually be found either in defective bypass diodes, in internal short-circuits, or in a cell mismatch.

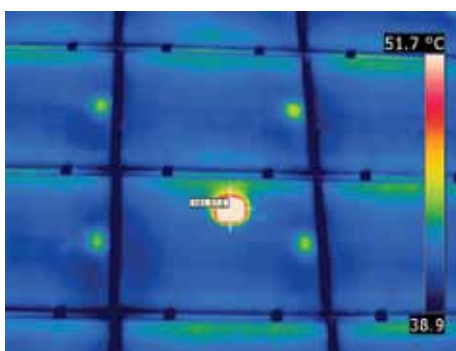
This hot spot within one solar cell indicates physical damage within the cell.

Shadowing and cracks in cells show up as hot spots or polygonal patches in the thermal image. The temperature rise of a cell or of part of a cell indicates a defective cell or shadowing. Thermal images obtained under load, no-load, and short-circuit conditions should be compared. A comparison of thermal images of the front and rear faces of the module can also give valuable information. Of course, for correct identification of the failure, modules showing anomalies must also be tested electrically and inspected visually.
